# Manhole Inspection Summary

Manhole # S43W\_\_036MH

**Location** Address: **1428 e. fort ave.**

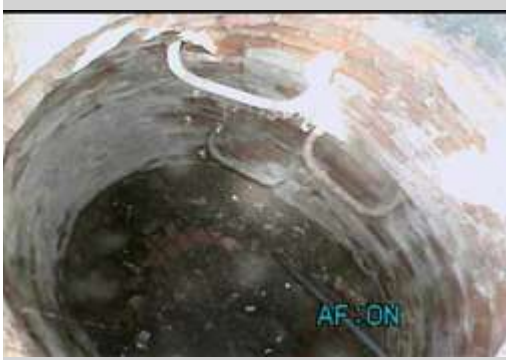
Defect 2

channel debris

corr steps

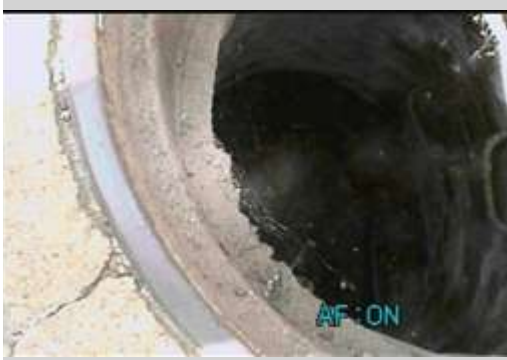
Defect 1

Offset: **1** (in.)

frame offset

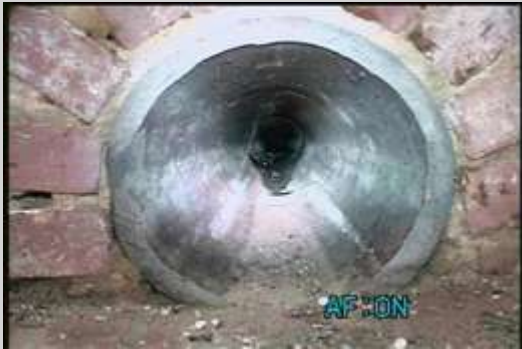
12 O'Clock Outflow

8 in. Circular Gravity Sewer  
Pipe Out @ 12 O'Clock

Pipe Material: **Clay** ☐ Pipe Lined

Infiltration: **None** Pipe Seal Cond: **Unknown**
